Results of Additional Soil Borings Investigation

Detrex Source Control Area – Fields Brook Superfund Site

Detrex Corporation, Ashtabula, Ohio

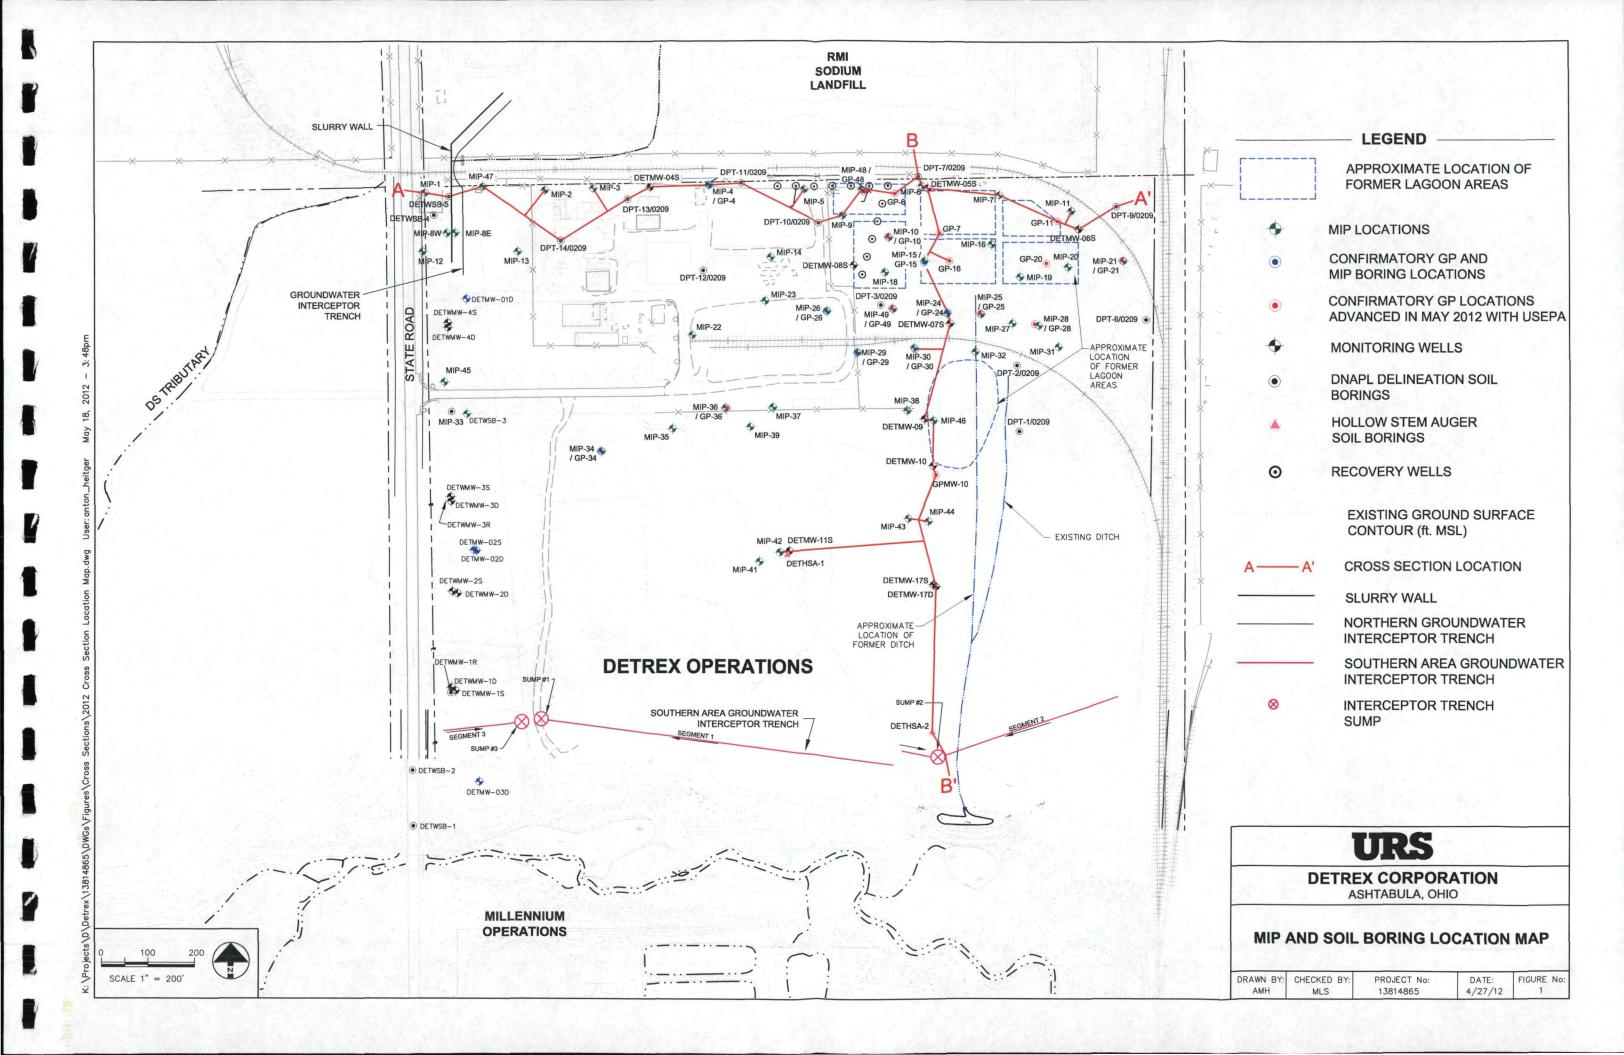
During the two day sampling program, fourteen (14) soil borings were completed within various areas at the Detrex Facility, which included the following: previous MIP locations not sampled in March 2012; areas outside of plant operations, and areas within the northeastern portion of the facility where the former lagoons where located. **Figure 1** provides an updated

drawing to shown locations of all MIP and soil boring locations. This figure also shows the approximate boundaries of the former lagoons in the northeast portion of the facility. The approximate locations of the former lagoon boundaries were based on a historical air photograph from the area circa 1955-1960. A copy of this photograph is provided in **Appendix A. Figure 1** also shows the locations of geologic cross sections A-A' and B-B', which are attached as **Figures 2** and **3**, respectively.

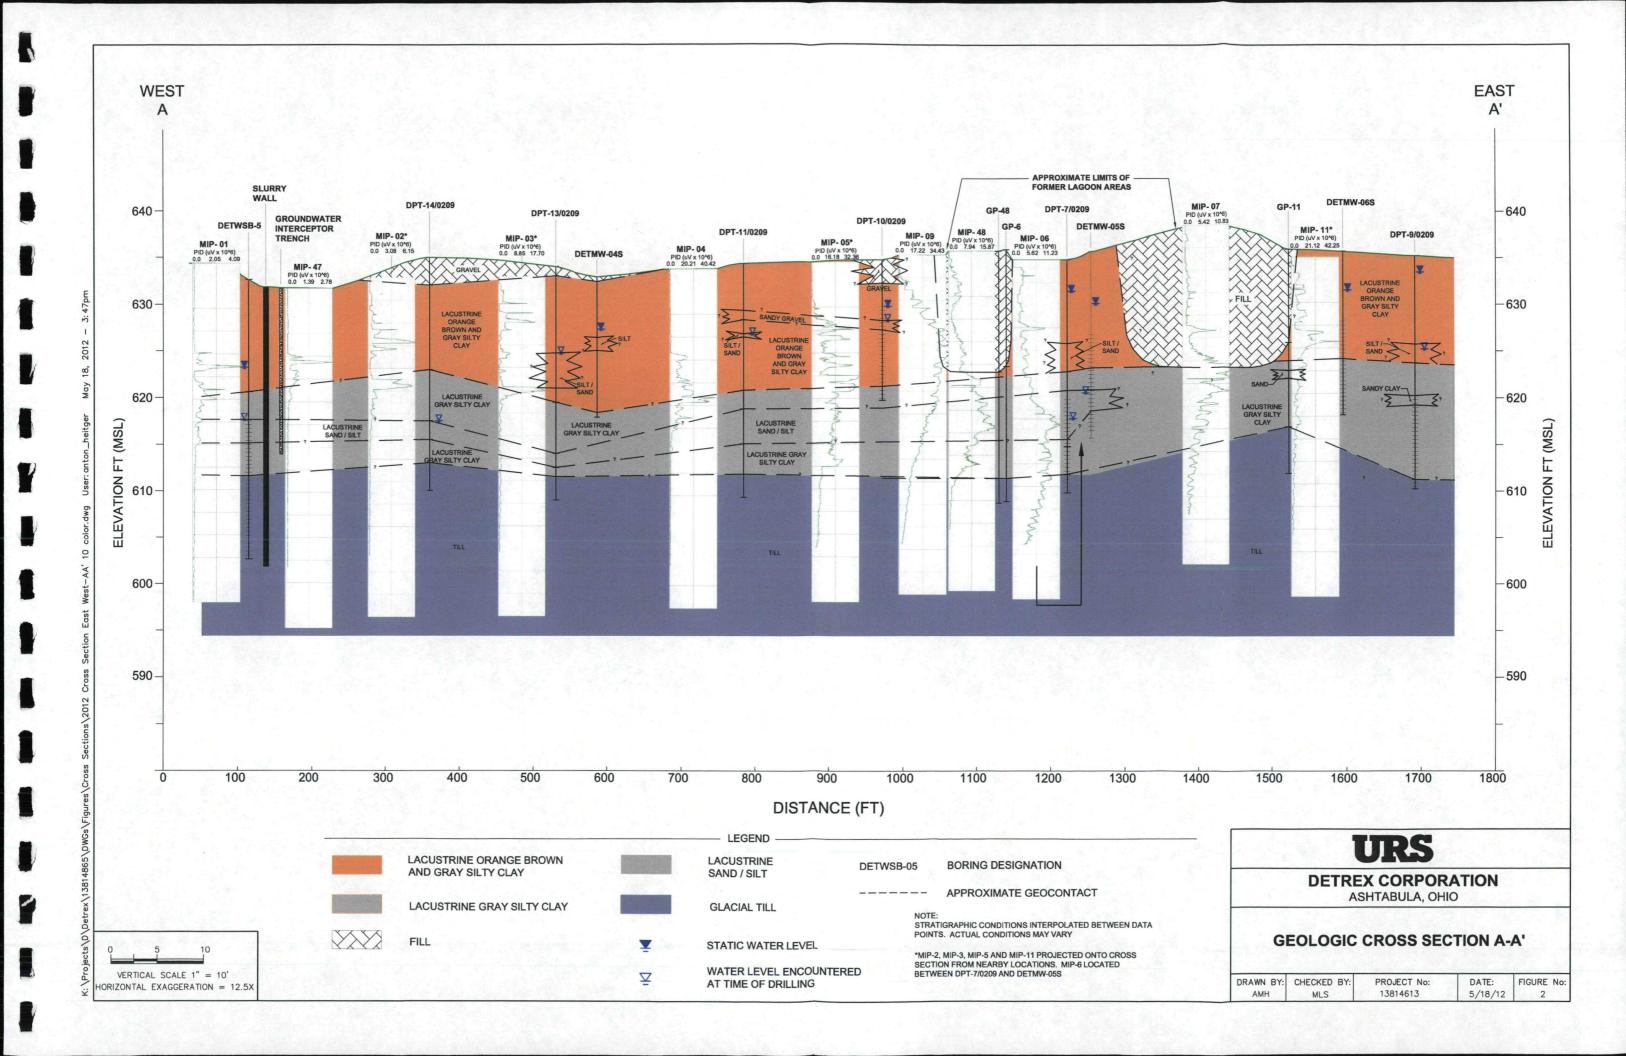
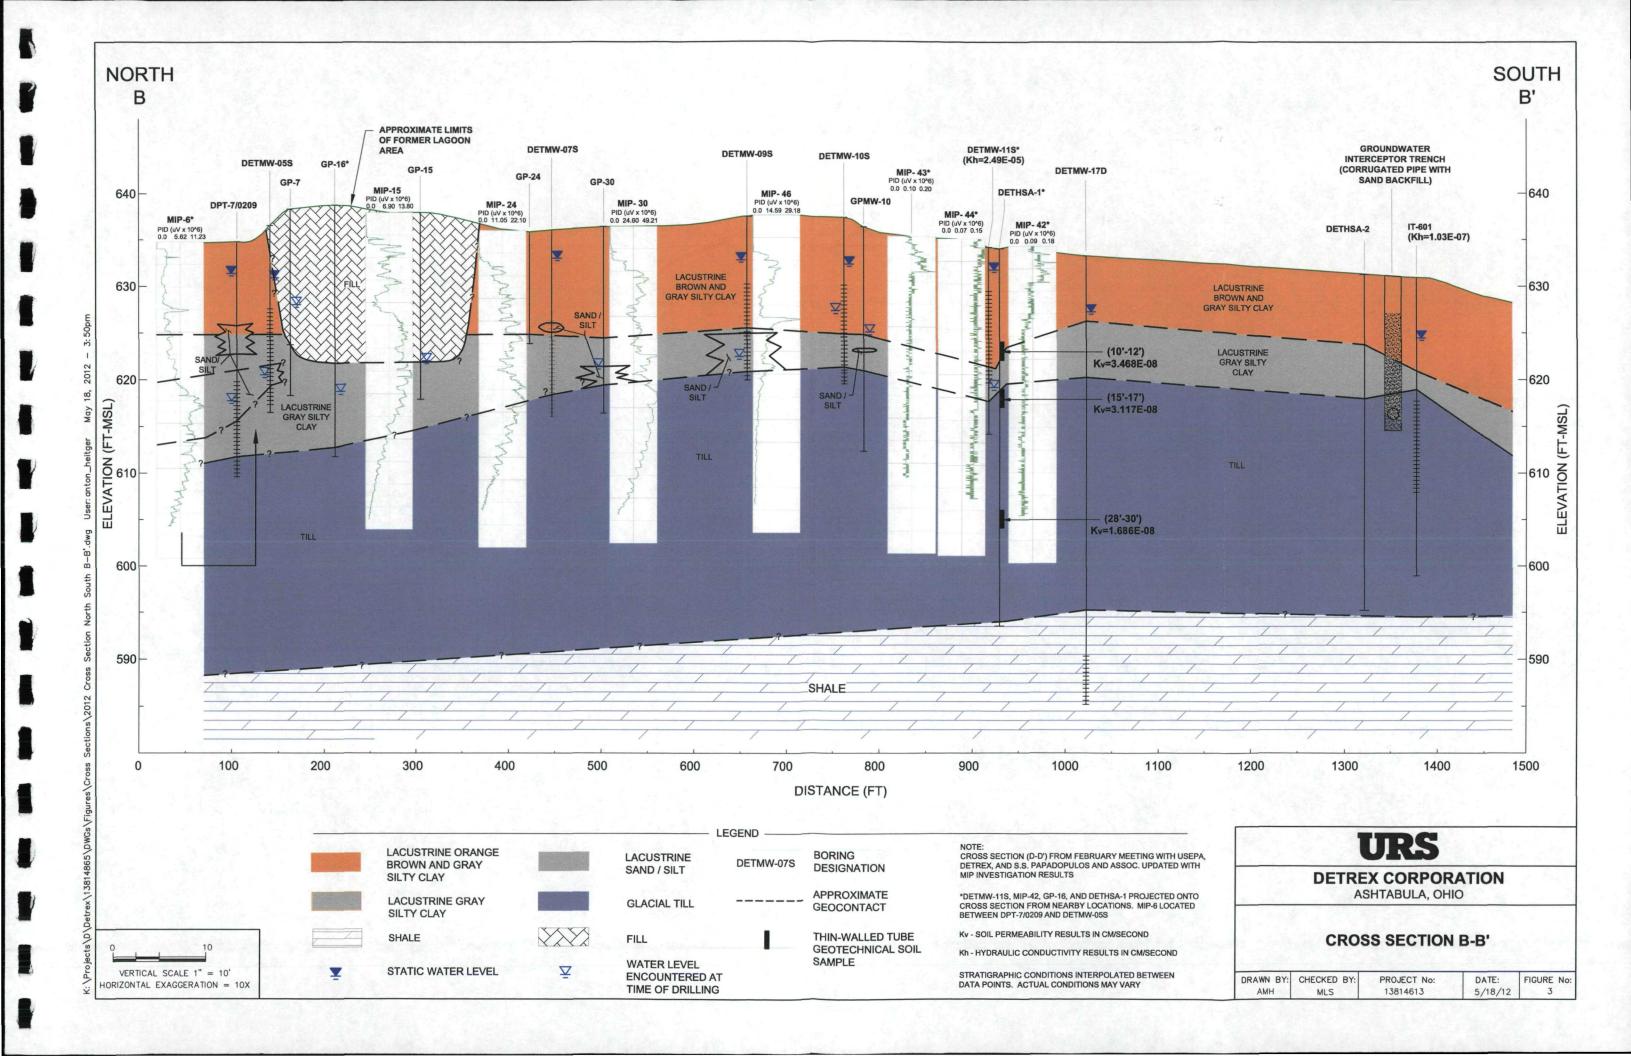
In the April 30, 2012 MIP/Soil Boring Investigation letter report submitted to USEPA, a revised Site Conceptual Model (SCM) was developed. The soil boring data collected during May 1-2, 2012 additional sampling program has subsequently been used to update the existing geologic cross sections. **Figures 2** and **3** provide geologic cross sections that illustrate the site and the approximate boundaries of the former lagoon area that has been backfilled with clay soils.
